# THE IMPORTANCE OF THE PREVIOUS STUDIES IN THE INTERVENTIONS OF REBURFISHMENT: A PRACTICAL CASE, THE MAJOR SEMINAR OF COMILLAS (CANTABRIA, SPAIN)

<sup>1</sup> Villegas, L; Lombillo, I\*; López, F.

<sup>1</sup> Building Technology R+D Group of the University of Cantabria. Department of Structural and Mechanical Engineering.  
E.T.S. de Ingenieros de Caminos, Canales y Puertos. Dpto. de Ingeniería Estructural y Mecánica. Av. Los Castros, s/n. 39005 Santander (Spain)  
[gted@unican.es](mailto:gted@unican.es)

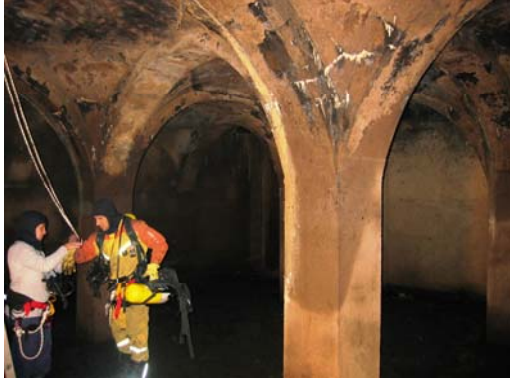
Fig. 5 “Details of the inspection in the underground water tank of the east cloister”

We also performed an inspection of the underground water tank in the east cloister (Fig. 5). For this reason and because of their special characteristics of confined space, it was thought appropriate to know the quality and characteristics of the atmosphere to ensure the safety and health of the technicians that should inspected the tank. We proceeded to measure the concentration of oxygen, carbon monoxide, carbon dioxide and certain flammable gases with the aim of assessing the potential explosive atmosphere exists. The underground water tank consists of two enclosures separated by an intermediate wall, with a total surface of 204.5 m<sup>2</sup>. The structure consists of square pillars (of 49 cm of side) which receiving the load of the vaults.

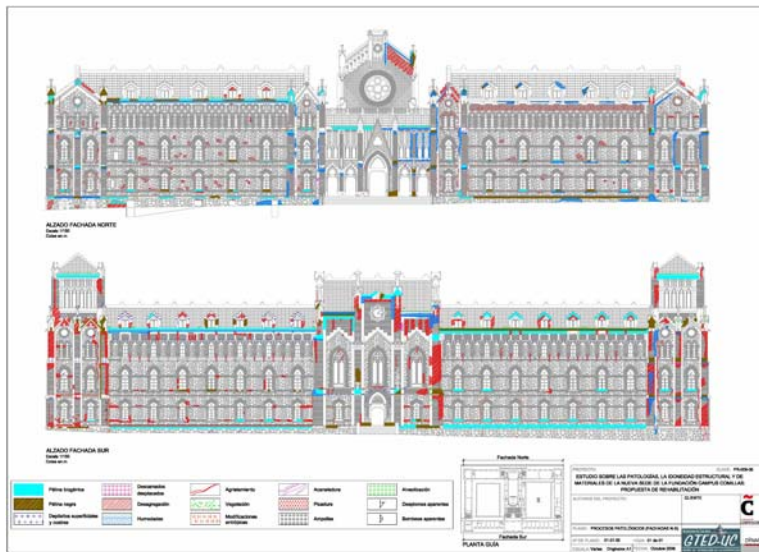
Fig. 10 “Survey of pathological processes of the north facade (top) and the south facade (below) of the Major Seminary of Comillas”

The process for carrying out this work was a detailed visual inspection. With the information obtained was an uprising of the pathological processes involved (Fig. 10). Similarly attached photos of every detail of the pathological condition and its location within each wall. Finally, it was attached, in the form of sheet, a description of each pathological process and the causes attributable most likely related with each injury.

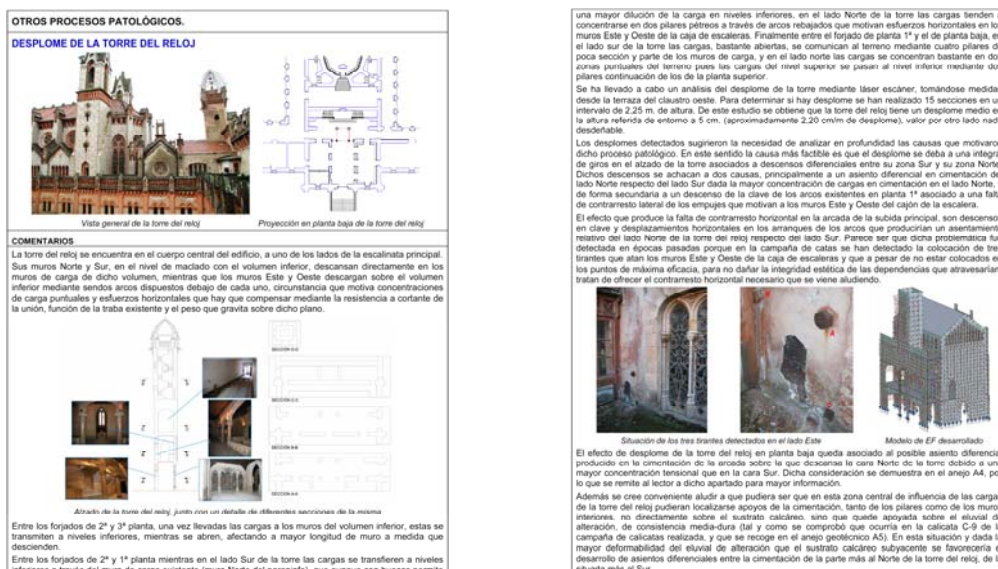
Fig. 13 "Example of description of the pathological process associated with the pancake detected in the clock tower"

Because at first sight appeared to detect a drop in the tower, it conducted a hypothetical analysis of movement through three-dimensional laser scanner. In that study concluded that there was a drop of 2.20 cm / m in the tested area (5 cm in total length of 2.25 m).

The most likely cause is that the pancake was due to one of the standard drawings of the tower associated with decreases differential between south and north. These declines were attributed to two causes, primarily a differential seat in the foundations of the North side respect to the South side, given the greater concentration of loads on foundations in the northern side, and secondary to a decline in the key of the arches in 1<sup>st</sup> floor, associated with a failure to counter lateral thrusts of impacting on the east and west walls of the staircase.

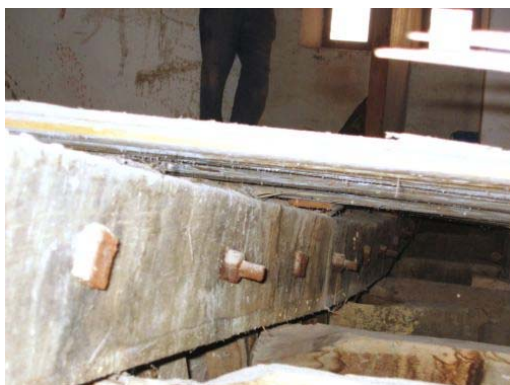
Deflections in excess are observed in the ceiling of the auditorium shaped (Fig. 14) due to the great length and that only exists two ready-bearing elements as a wooden lattice beam. Associated with this, it has seen a failure in the top (compression head) of one of the wooden lattice beams, it has suffered a compression instability being subjected to lateral buckling (especially severe damage as possible breakage of fragile or collapse without warning).

Fig. 14 “Lateral buckling cord compression from one of the main beams”

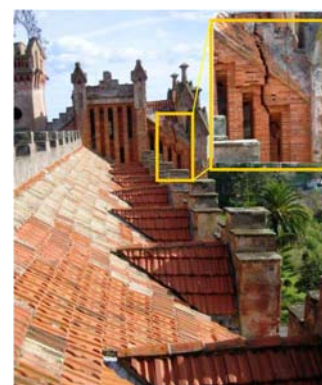
There are also cracking on the sides of the main facade of the building (south-west and south-east facade). In the south-west, the Fig. 15 shows a cracking amplitude very important and serious (about 6 cm and through the side wall sections): The main central facade is without link and collapsed outwards in the 3<sup>rd</sup> floor.

The deductive process followed has led to the conclusion that the main cause is associated with the rupture in the plane of greatest weakness of the walls perpendicular to the facade to the south wind suction is subjected to it in its central zone, as given the current configuration of the building most of the traction efforts generated are to be transmitted to the walls.

Fig. 15 “Overview of the South facade crack from the West tower”

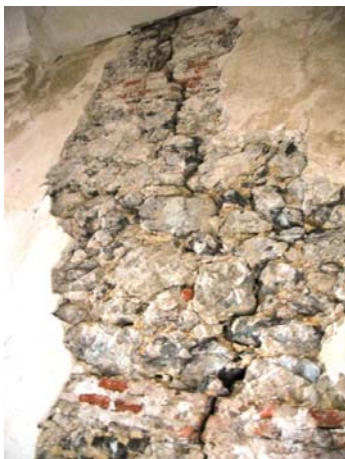
There are pathological processes associated with sucking wind, horizontal thrusts not compensate and bad attachment between the north facade’s wall and the perpendicular walls that forms the staircase attached to the church. Important cracking were observed in the side walls. After making three surveys and remove the revoke it is found that such cracks

have a large amplitude (Fig. 16) and depth, even in some cases are interns in the entire thickness of the wall.

Fig. 16 "Taste and cracking on the west wall of the East staircase. Landing between 2nd and 3rd floor"

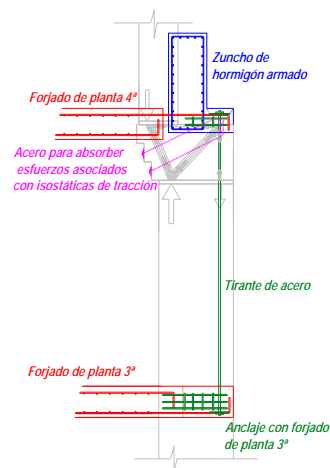
For its part, in connection with the verification of structural load-bearing walls of the SW tower can be concluded that, in general, all the assessments made in the control stresses points in relation with compression mechanisms were ok. Also in the plane of intersection between the coronation prism and the bearing walls underlying the major tractions occurs in the central part of the wall and not on the corners, because in these, the charges associated with the pinnacles helps focus from loads applied in this plane, the eccentricity of the resultant reduced significantly and therefore the traction produced.

Fig. 17 "Drawings relating to the possible reinforcement of the union area of coronation prism and body of the tower"

Given the need to compensate these traction efforts some solutions for possible reinforcement were proposed. One possible solution mentioned (Fig. 17) is the provision of a chain of tied reinforced concrete that hooping the four walls, a reinforced concrete floor with embedded armed timely two-way which fix (at the level of each nerve) in the hooping and a tight well-anchored vertical masonry wall or at the lower level floor.

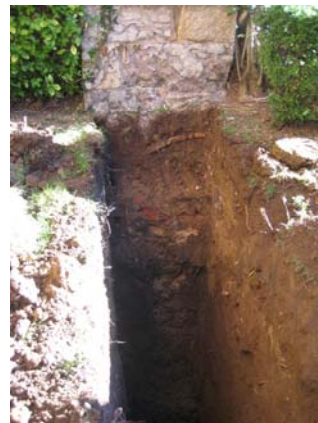
In relation to the foundation can be concluded that the type of foundation used in all cases is very similar (Fig. 19), with load bearing walls supported on ditches filled with limestone gravel, with some degree of cementation. However, the geometry and composition of the foundation differs from other points. Apparently, in all cases, with greater or lesser depth and width of the ditch limestone gravel, transferring loads to the rock substrate.

Fig. 19 "Soil Pit for recognition the foundation of South facade wall"
