# THE IMPORTANCE OF THE PREVIOUS STUDIES IN THE INTERVENTIONS OF REBURFISHMENT: A PRACTICAL CASE, THE MAJOR SEMINAR OF COMILLAS (CANTABRIA, SPAIN)

<sup>1</sup> Villegas, L; Lombillo, I\*; López, F.

<sup>1</sup> Building Technology R+D Group of the University of Cantabria. Department of Structural and Mechanical Engineering.  
E.T.S. de Ingenieros de Caminos, Canales y Puertos. Dpto. de Ingeniería Estructural y Mecánica. Av. Los Castros, s/n. 39005 Santander (Spain)  
[gted@unican.es](mailto:gted@unican.es)

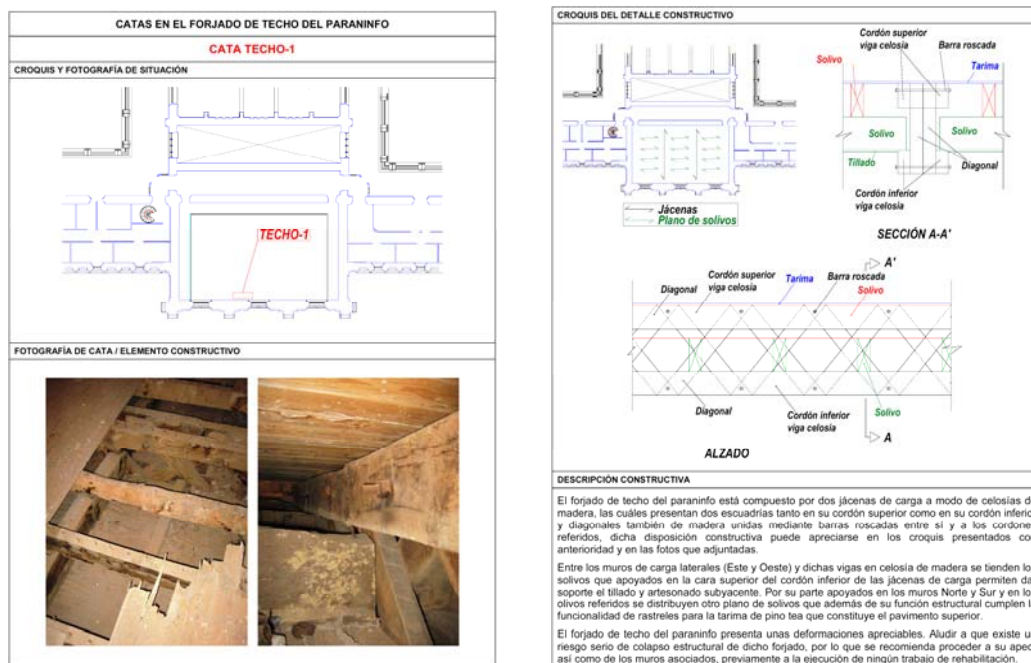
Fig. 4 "Example of sheet model, specifically of the second floor (roof) of the auditorium"

With these goals has been to conduct a series of surveys in strategic locations. For each of these, it was made a sheet (Fig. 4) which includes its location within the building, standard photographs of situation, detail drawings with dimensions and geometry, and a written description of it.

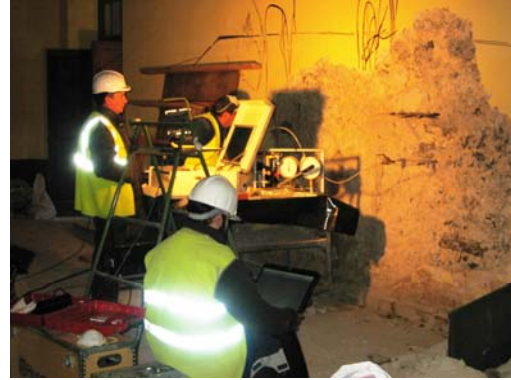
Fig. 6 “Instant during a double flat jack test”

In relation to minor destructive testing [3, 4, 5] allude to several tests were made: Simple flat jacks and hole drilling (Fig. 7) to obtain tensional levels of compression, double flat jacks (Fig. 6) to obtain the elastic modulus and Poisson ratio, acoustic techniques (Fig. 8) to study the integrity of structural elements and estimate their mechanical properties, and infrared thermography (Fig. 9) to assess, qualitatively, determined phenomena involved.

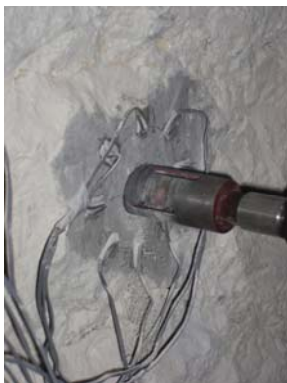
Fig. 7 “Hole Drilling test”

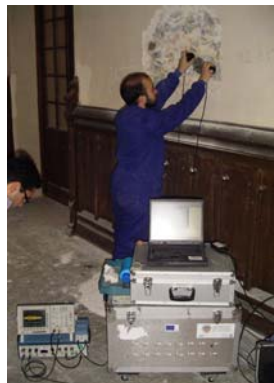
Fig. 8 “Impact echo test on a masonry wall”

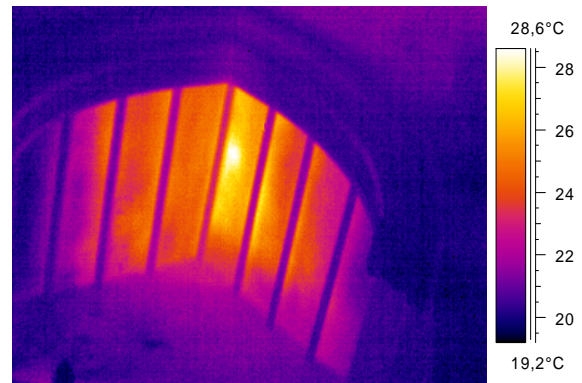
Fig. 9 “Infrared thermography on the cover of one of the domes of the Church's Seminar”

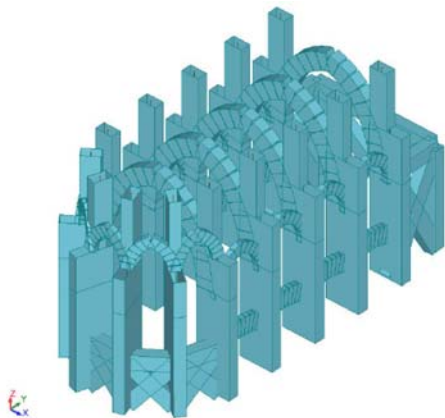
- The church (Fig. 18) which includes a main structure formed by buttresses and arches along the top, floors, roof trusses and towers of the same.
- In South Central Zone, which is formed by the entrance hall, auditorium, roof and clock tower, also examines the facade that closes these volumes.
- Wooden floors of the building.
- Underground water tank situated in one of the cloisters of the building.

Fig. 18 "Bar model of the church's Seminary in Comillas"

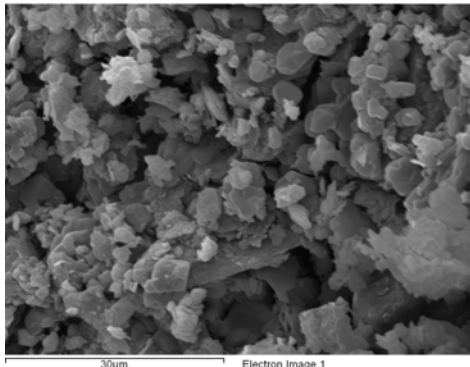
Have raised a series of experiments applied to each group of materials considered (stones, bricks and mortar). The characterization of the chemical composition of the materials was made by microscopy (Fig. 20), elemental microanalysis with electronic probe (EDAX) and mineralogical analysis by X-ray diffraction (XRD). The physical characterization of the rock was made with tests for the determination of apparent and relative densities, porosity and water absorption of each of them. The mechanical characterization of the elements of stone and brick was conducted by testing samples to estimate the mechanical resistance to

Fig. 20 "Microphotography the brick structure"

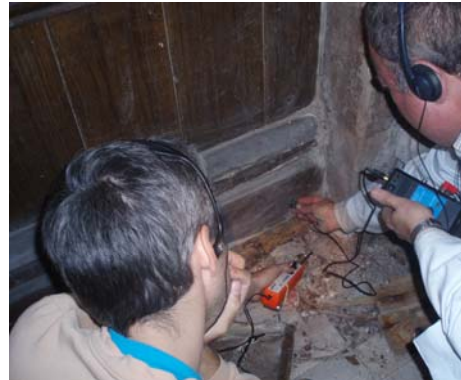
This study aimed to analyze the degradation of existing elements of wood in the Major Seminary of Comillas, for this, some areas was selected for sampling, where the study was more intense, as well as other specific areas. To make the analysis was performed: A visual inspection of the signs of deterioration caused by organisms attacking wood surface by observation and/or computer vision techniques (endoscope), the relative humidity measurement of the woodwork, through analysis instruments; conducting tastings with specific drills for wood to determine the hardness and the depth (pseudo non-destructive methods); sonic methods (Fig. 21) for the determination of activity of the hypothetical bodies xylophages and analysis information gathered during visits to work for the state in which the

Fig. 21 "Sonic methods for the determination of activity of the hypothetical bodies xylophages"

In general, infestation which has regard to the building "Annobium" and "Lyctus" is entirely acceptable given the years of construction and is solvable with injection treatments (risk 3) and spray (risk 1 and 2) in the timber to be make rehabilitation. Fungal problems are solved, as the building and restoring the wetlands disappear, by impregnation of fungicides.
